INDOOR AIR QUALITY ASSESSMENT

**Mary A. Dryden Memorial Elementary School Annex
190 Surrey Road
Springfield, Massachusetts**

Prepared by:
Massachusetts Department of Public Health
Bureau of Environmental Health Assessment
Emergency Response/Indoor Air Quality Program
July 2003

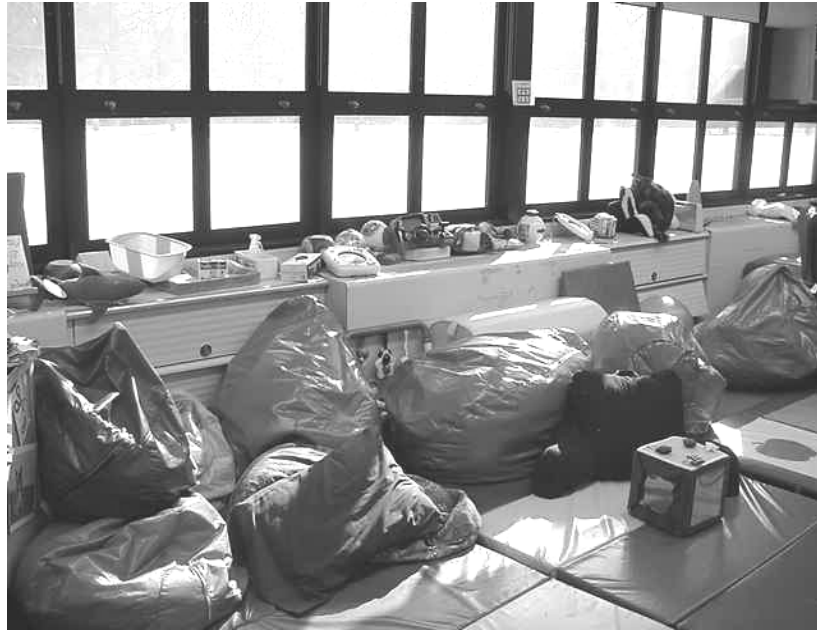
Picture 1

Fresh air in classrooms is supplied by a unit ventilator (univent) system (see Picture 1). Univents are designed to draw air from outdoors through a fresh air intake located on the exterior wall of the building and return air through an air intake located at the base of each unit (see [Figure 1](#)). Fresh and return air are mixed, filtered, heated and provided to classrooms through a fresh air diffuser located on the front of the unit. Univents were found deactivated, which prevents a continuous source of outside air to provide ventilation. Obstructions to airflow, such as beanbag chairs in front of univent return vents were noted (see Picture 1). In order for univents to provide fresh air as designed, univent air diffusers and return vents must remain free of obstructions. Importantly, these units must be activated and allowed to operate.

Univent, Note Bean Bag Chairs Blocking Univent Return Vent

2. Remove all blockages from univents to ensure adequate airflow. Clean interiors of univents regularly.
3. To maximize air exchange, the BEHA recommends that the ventilation system operate continuously during periods of school occupancy independent of classroom thermostat control.

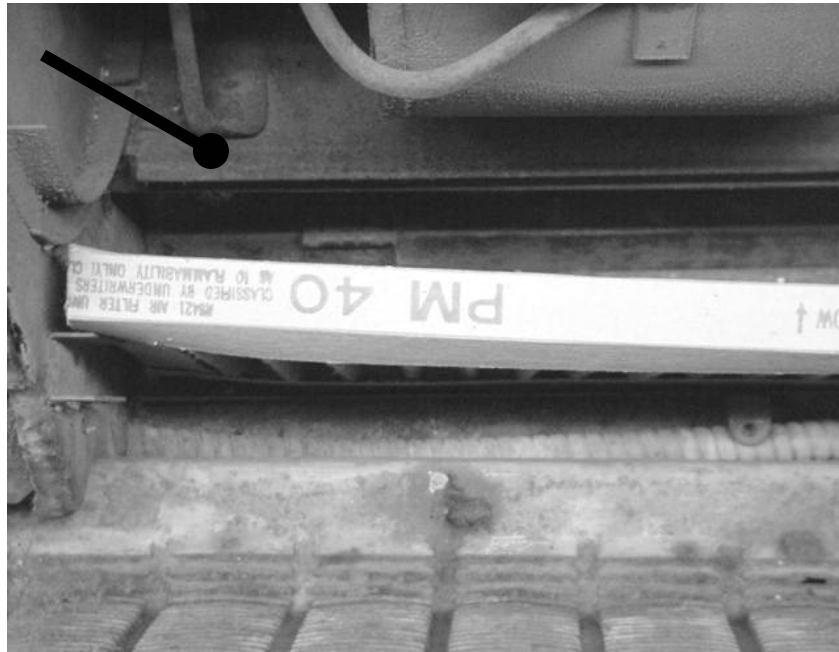
The univent in classroom 17 was opened and examined. Airflow into the univent is controlled by a pendulum louver (see Picture 2). The position of the louver determines the amount of fresh to return air from the classroom. The louver in Picture 2 is fixed in the closed position, preventing fresh air intake by the univent. Assuming that this univent is representative of others, the ventilation system is not able to draw fresh air from outdoors. The sole means for introducing fresh air into the building is through opening windows.

Pendulum Louver in Univent

1. Examine each univent for function. Survey classrooms for univent function to ascertain if an adequate air supply exists for each room. Consider consulting a heating, ventilation and air conditioning (HVAC) engineer concerning the restoration of univent fresh air control dampers throughout the school.

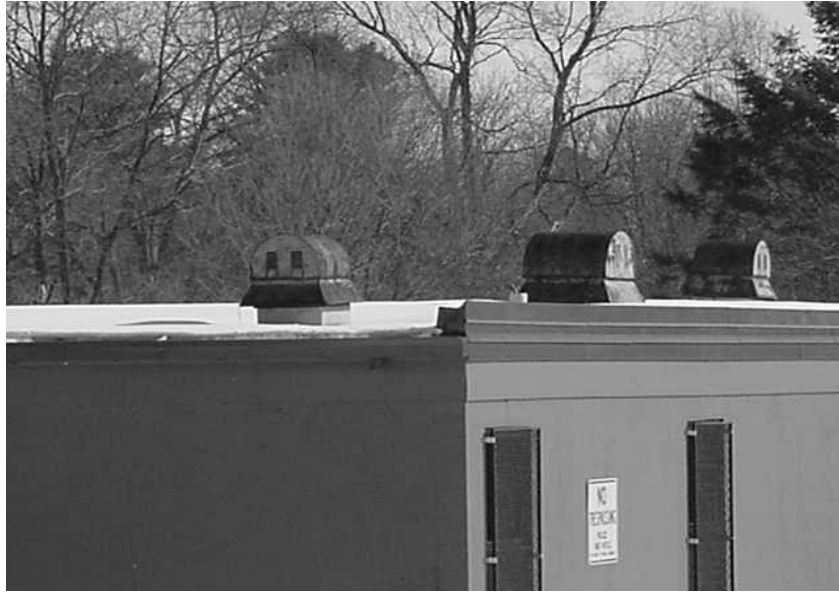
Picture 3

A mechanical exhaust vent exists in each classroom, consisting of a grill installed in a metal duct. The metal ductwork is connected to recently installed rooftop exhaust motors (see Picture 3). Both classroom exhaust vents were operating during the assessment.

Rooftop Exhaust Vents

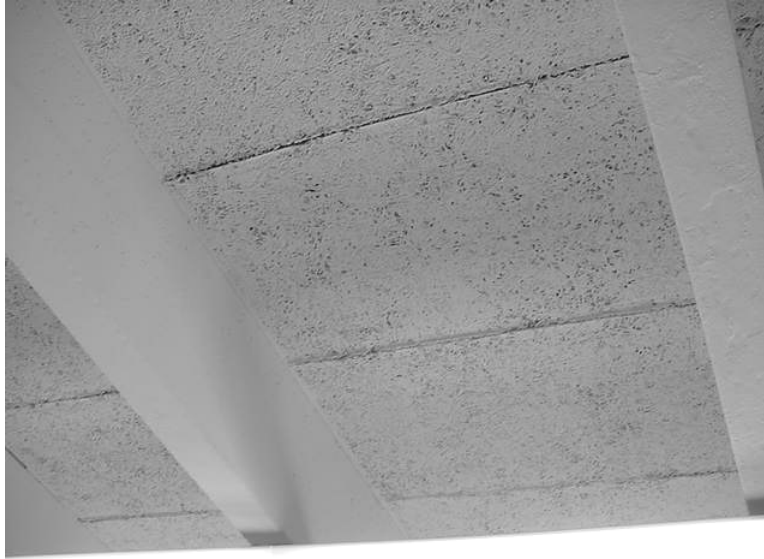
Picture 4

The design of the roof makes it prone to developing water leaks. The MDESA has a flat roof covered with a rubber membrane. No drains appear to have been installed in the roof, which seems to have a slight pitch. Water can accumulate on the roof, particularly with snow cover. Once a certain amount of water has pooled, the excess spills over the roof edge into a gutter system. The accumulation of water on the roof can lead to premature wear and create leaks in seams with the freezing and thawing cycle during cold weather.

Water-damaged ceiling tiles were observed, which indicates a current or historic water penetration problem. Tiles appear to be directly adhered to the ceiling. Replacement of the ceiling tiles is difficult, since their removal appears to necessitate the destruction of the tile (see Picture 4), which can result in the aerosolization of particulates. Water-damaged ceiling tiles may provide a medium for mold growth and should be replaced after a water leak is discovered.

Water Damage Ceiling Tiles

1. Water-damaged ceiling tiles should be replaced. These ceiling tiles can be a source of microbial growth and should be removed. Sources of water leaks (e.g. window frames and roof) should be identified and repaired. Examine the non-porous surface beneath the removed ceiling tiles and disinfect with an appropriate antimicrobial.

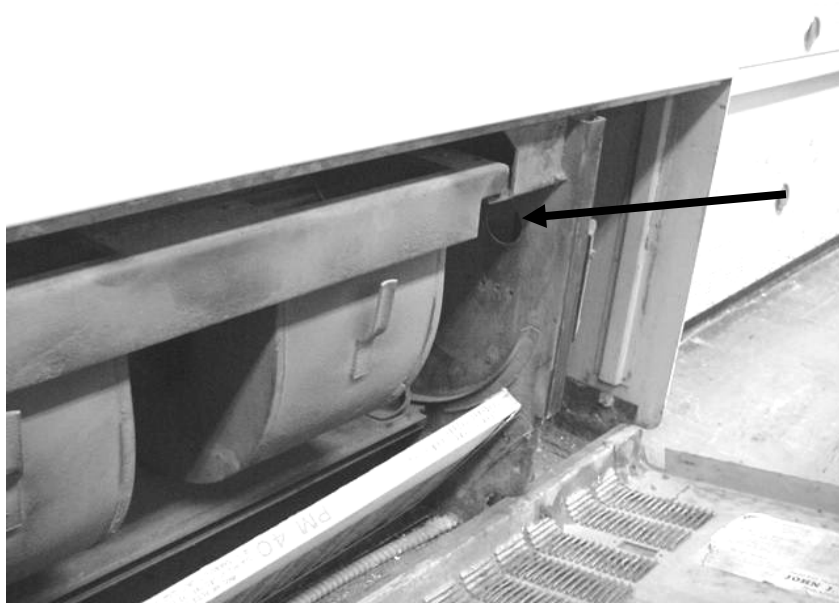
Picture 5

Walls in which univents are installed have spaces and holes within the air handling cabinet (see Picture 5). Of note is the heavy accumulation of dust around the edges of each hole, indicating unfiltered air passage. The existence of these holes provides for air to by-pass the installed filters, resulting in aerosolization of materials (e.g. dust, odors) from the classrooms. In addition, spaces exist around heating pipes that penetrate through the floor (see Picture 6). Spaces of this nature can result in the univent drawing air and debris from the wall cavity or crawl space and distributing these materials to the interior of the building.

Hole in Univent Cabinet

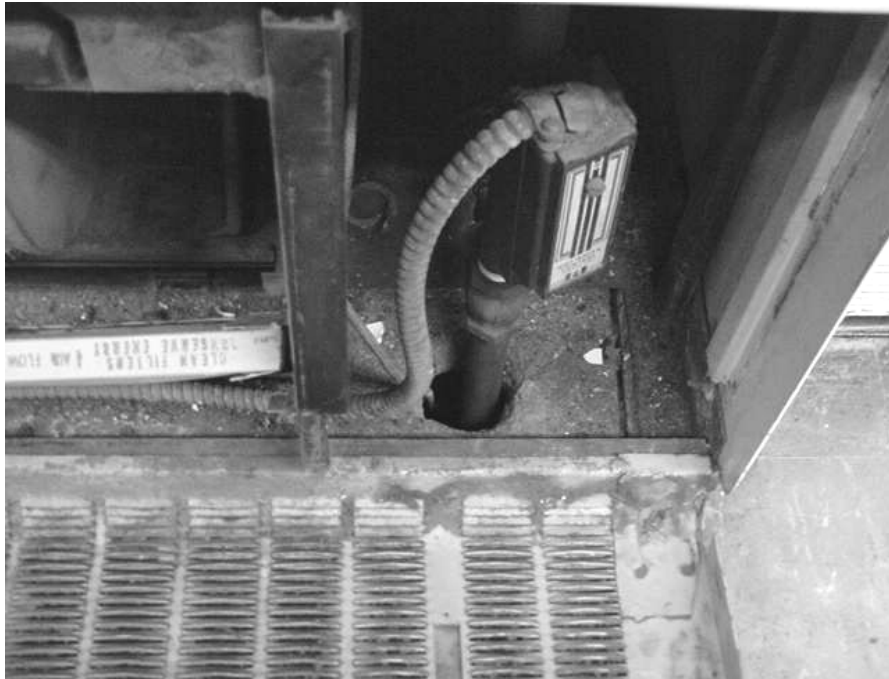
Picture 6

The interiors of both univents and radiators were examined and were found accumulated with dirt, dust and debris (see Picture 6). Univents have filters that provide minimal filtration of respirable dust. In order to avoid serving as a source of aerosolized particulates, the air handling sections of the univents should be regularly cleaned. In order to decrease aerosolized particulates, disposable filters with a high dust spot efficiency should be installed. The dust spot efficiency is the ability of a filter to remove particulates of a certain diameter from air passing through the filter. Filters that have been determined by ASHRAE to meet its standard for a dust spot efficiency of a minimum of 40 percent would be sufficient to reduce airborne particulates (Thornburg, 2000; MEHRC, 1997; ASHRAE, 1992). Note that increased filtration can reduce airflow produced by the unit due to increased resistance (called pressure drop). Prior to any

Hole in Floor for Heating Pipe, Note Dust and Debris Accumulation Inside Univent
